# Tremco Incorporated Vegetated Roof & Rainwater Harvest System

# Tremco North Building Renovation

# Green on Green Retrofit

# Vegetated Roof Concept

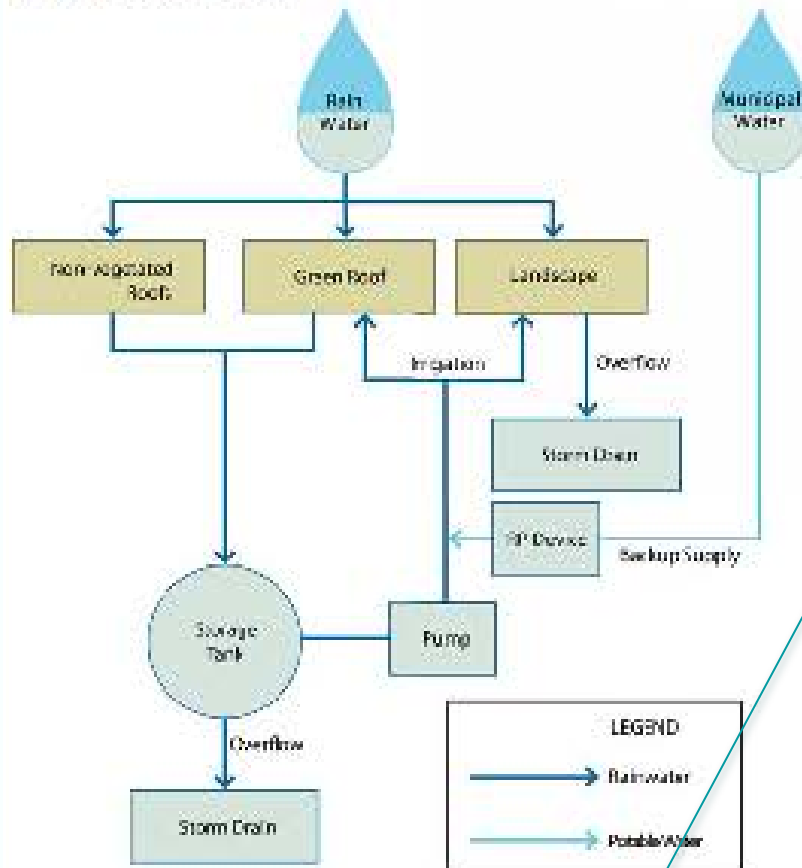
## WATER SYSTEMS

### Stormwater Reuse System Summary

Stormwater runoff from the vegetated and non-vegetated portions of the Tremco Headquarters roof is collected in a ground-level storage tank. The storage tank capacity is designed to retain 75% of a 20-year design storm event, and provide 100% of the annual irrigation demand. A potable back-up supply will ensure that the landscape receives adequate water when the tank's supply is depleted.

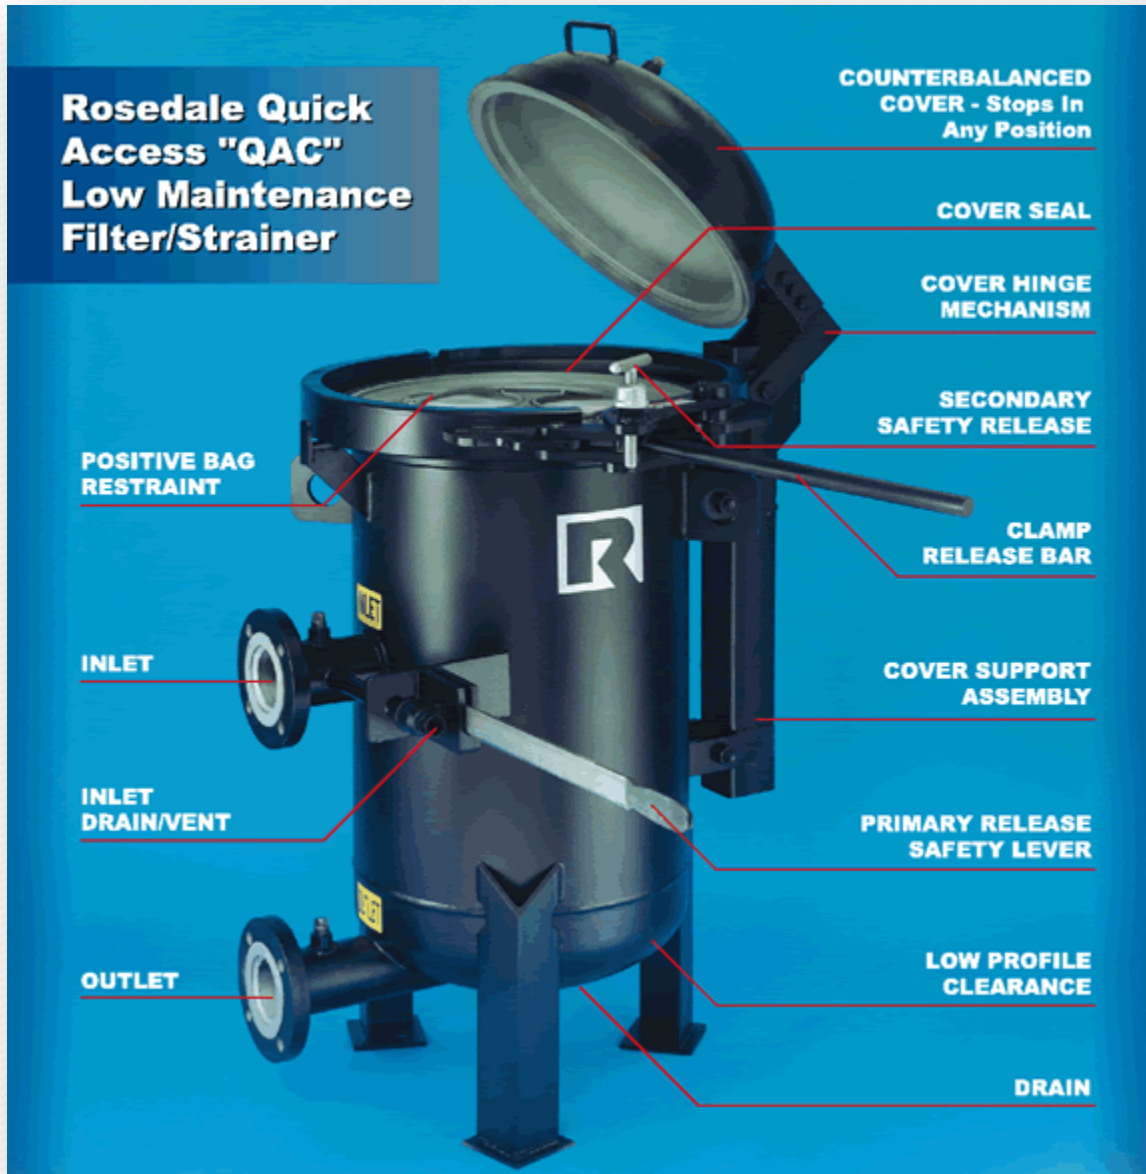
**Rosedale Quick  
Access "QAC"  
Low Maintenance  
Filter/Strainer**

*Captured stormwater moves from the parking lot storage vault through this particulate strainer/filter and into the cisterns.*

- Asphalt pavement
  - 50,000 sf; 1" rain per hr. = 31,000 gph
  - Petroleum, salt and particulate issues
- 15,000 gal storage Vault in parking lot
  - 15 hp, 500 gpm pump
  - High and low level controllers tied to automated building management system
- Captured water moves to 6 cisterns
  - Rosedale particulate filter/strainer holds back particulates from cisterns
- 6 – 2,000 gal cisterns store water for use on the roof utilize gravity to move water from one to the other

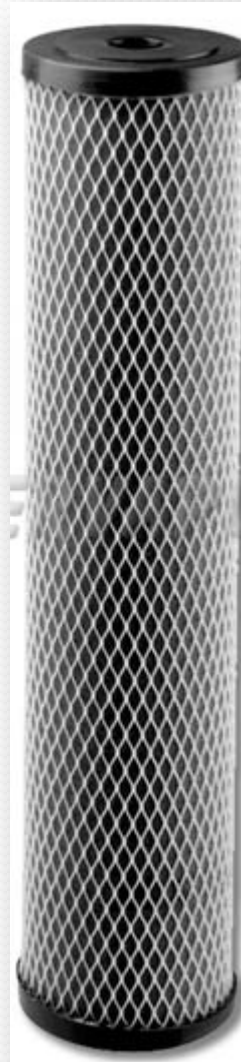
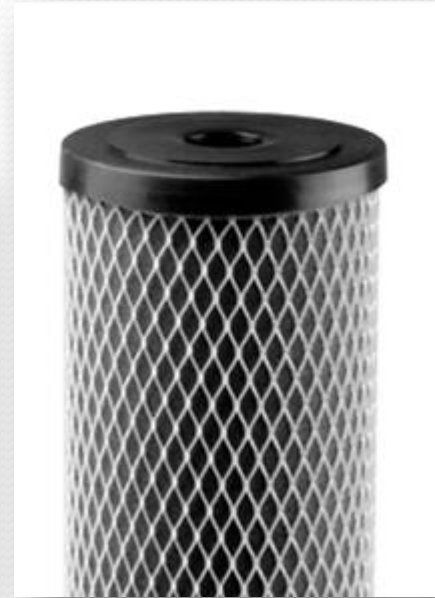
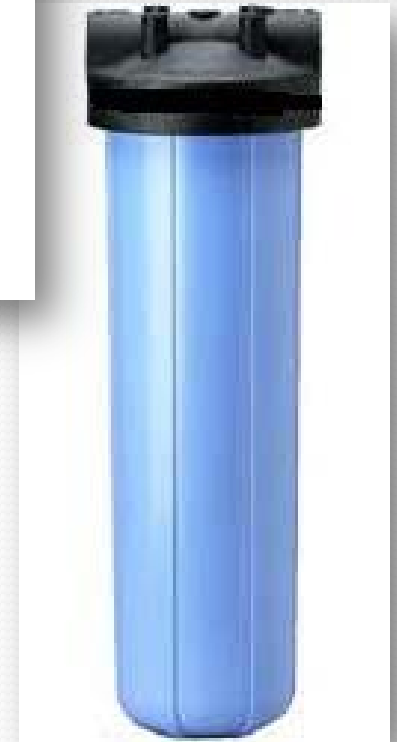
## Double Cartridge Filtration

*Stormwater is pumped to the roof from the cisterns and flows through two Pentek OAC-20BB cartridges.*

- *Oil adsorbing cartridges*
- *Filters out 90% of total hydrocarbons*
- *Modified cellulose-based filter media*
- *20" long*
- *High flow rate/low pressure drop*

- Cistern water moves to the roof via pump
  - 1.5 hp; 20 gpm; 60' head
- Hunter Controllers
  - 9 zones
  - Multi zone run times
    - Avoids cycling pump on and off
  - Solar synch
- KISSS Lo Flo Subsurface irrigation system
  - 0.5 gpm emitters
  - Capillary mat helps move water into surrounding soil
- Water runs through 2 Pentek OAD 20BB filters
- All tied into the automated building management system

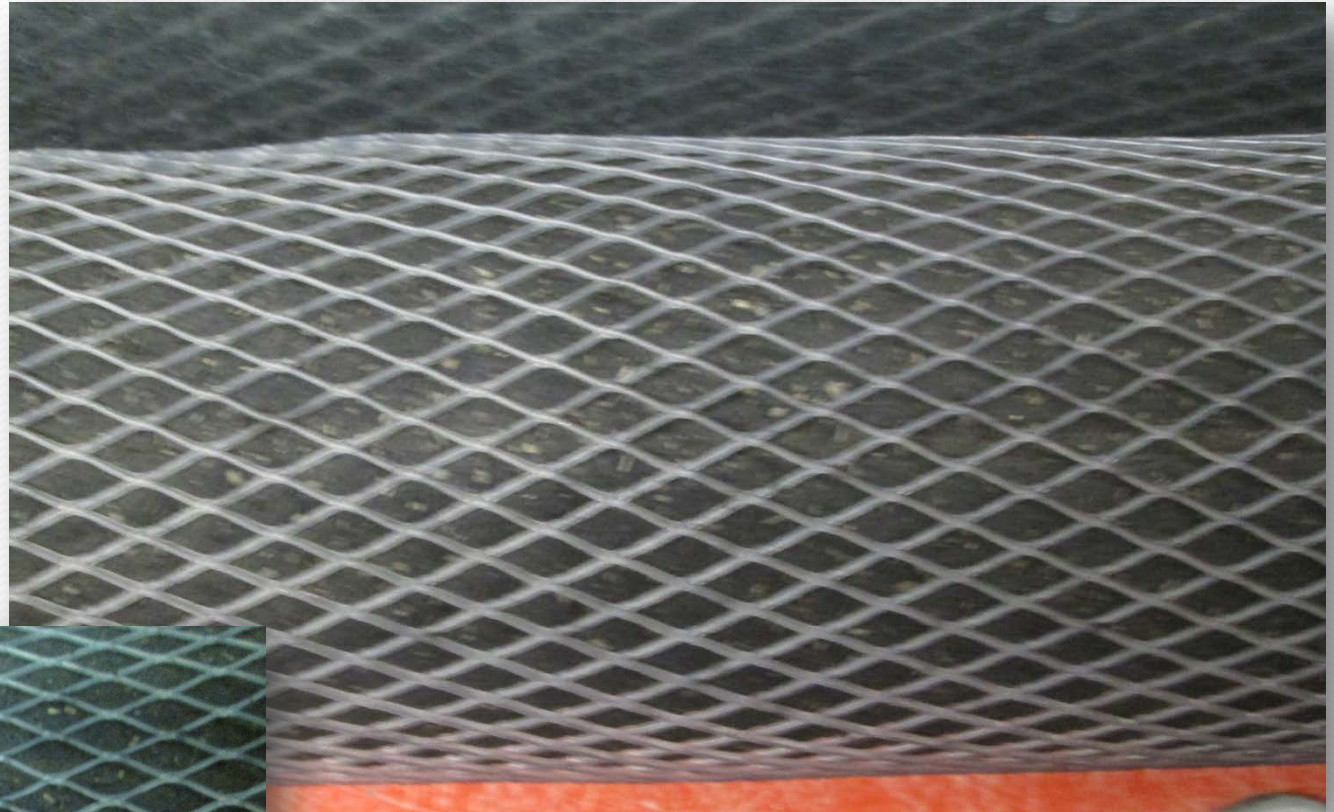
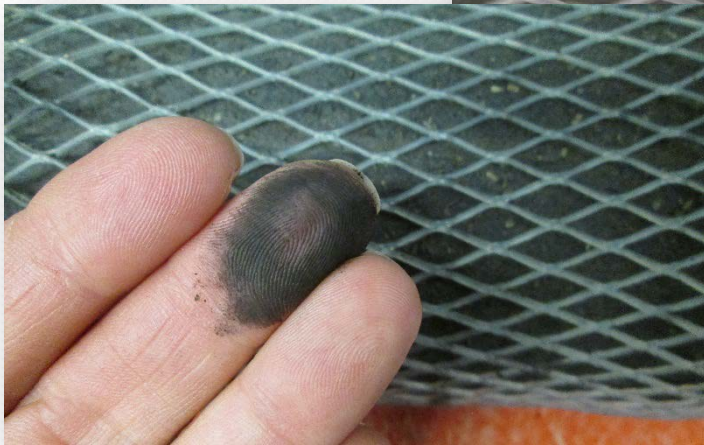
*Used Oil Adsorbing Cartridge...  
typically replaced once a month  
during the summer.*

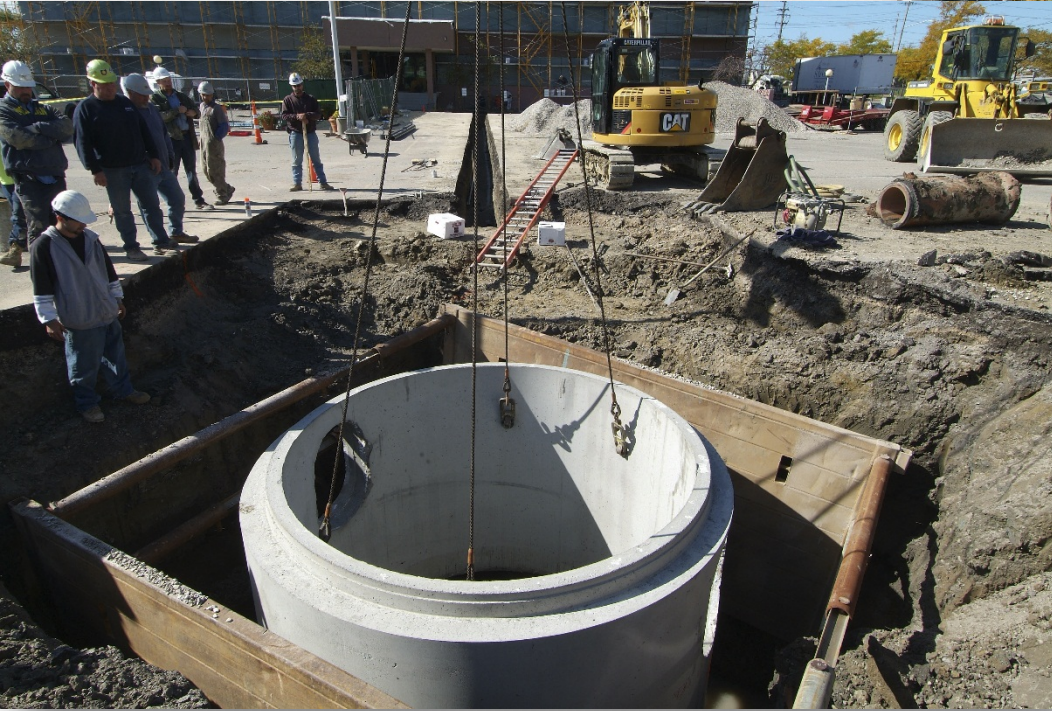
*Original outlet pipe for stormwater cut to receive vault and fittings.*

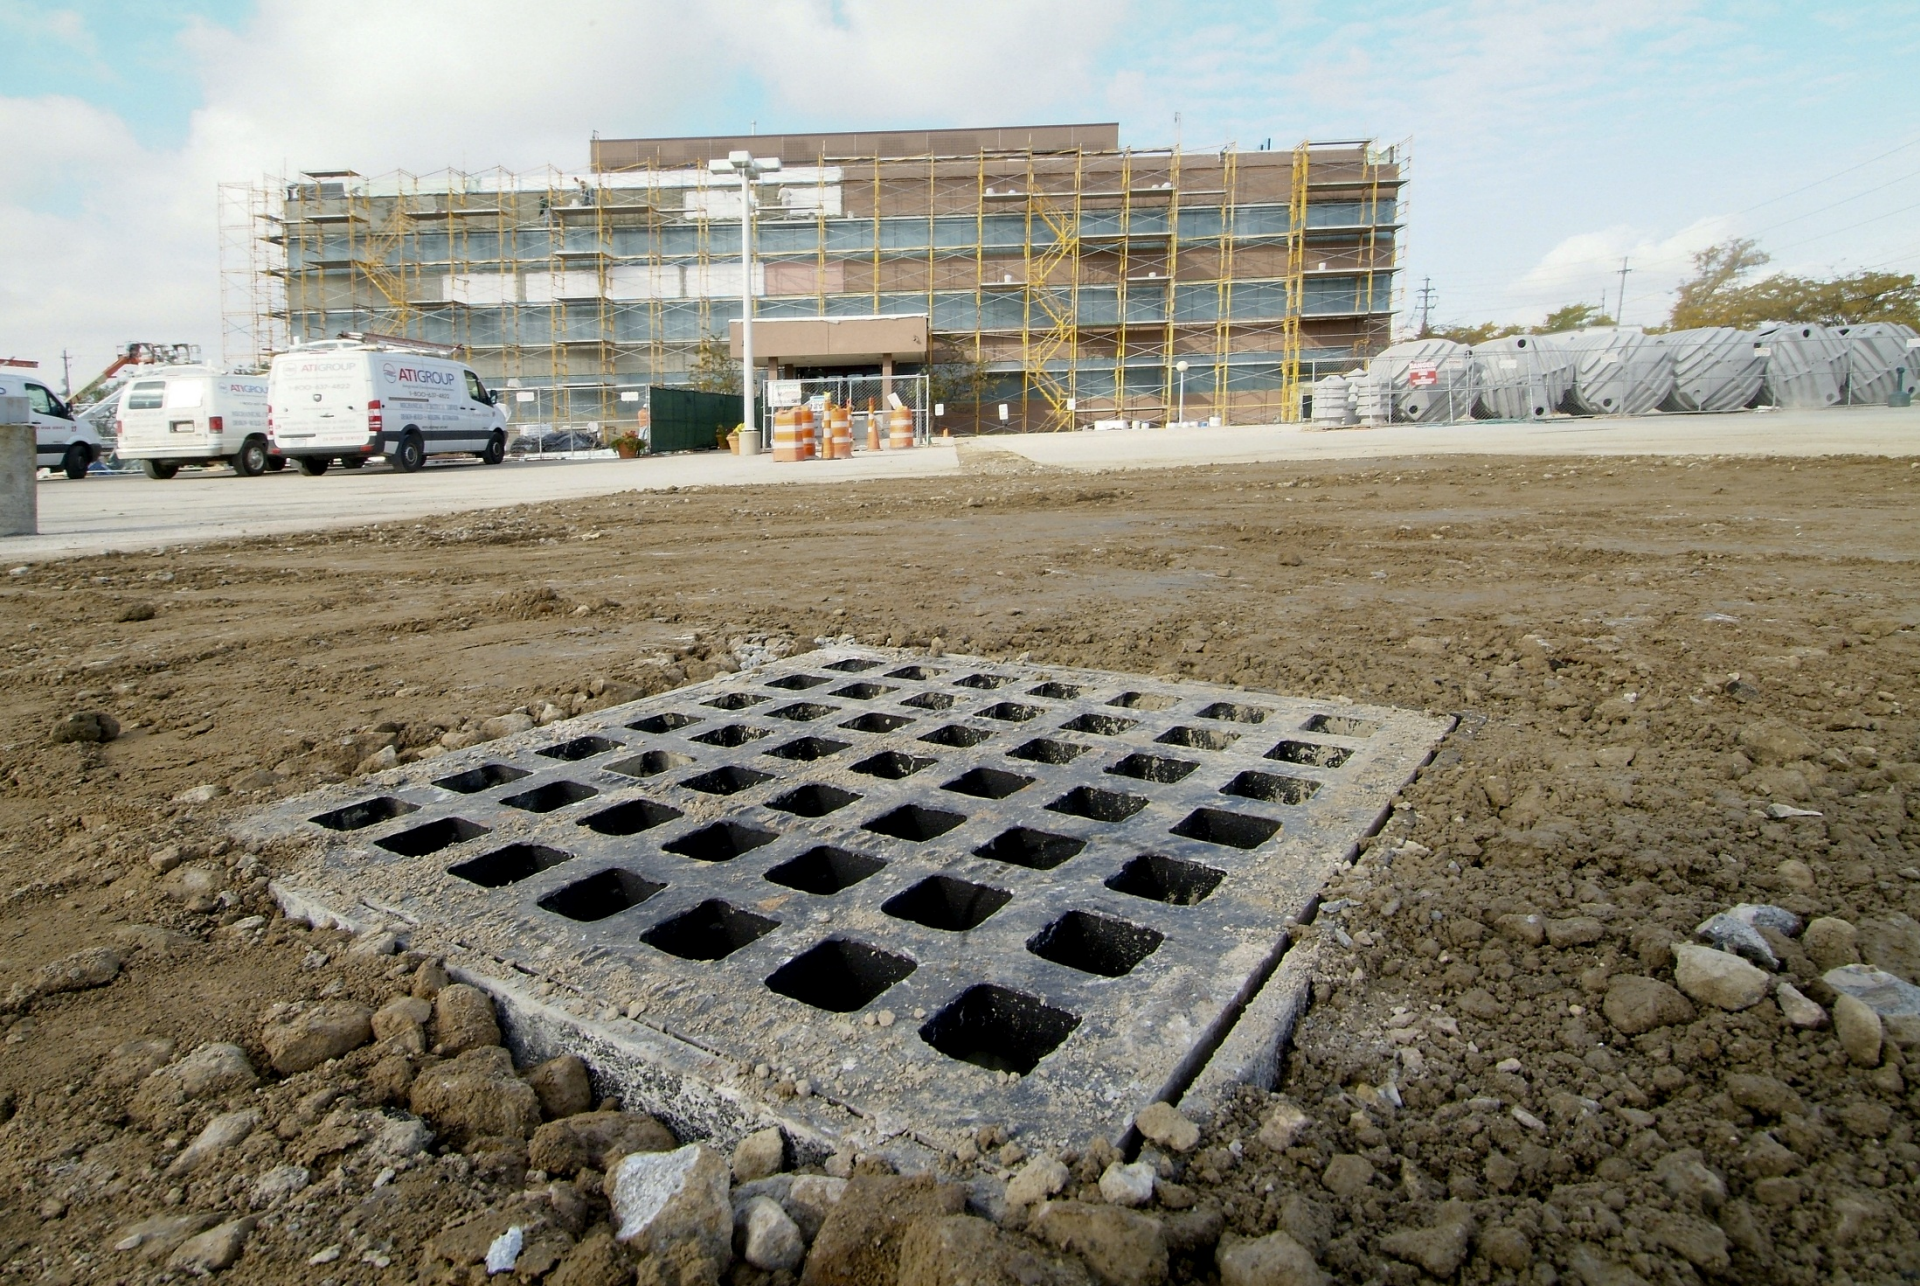
*Completed installation of vault with 6 cisterns waiting for installation.*

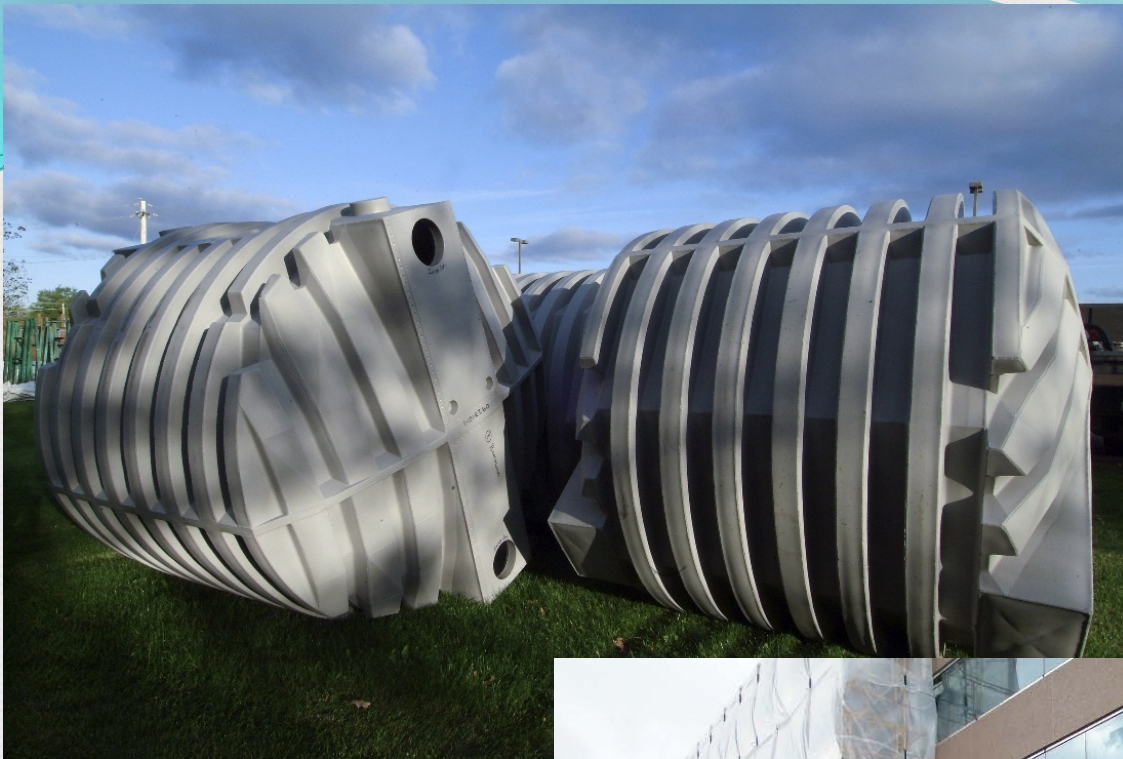
*Six 2,000 gal cisterns installed.*
