Career Technical Education Building
901 N. Colombo Drive, Sierra Vista, AZ

This 1200-gallon Corrugated Metal Pipe system was installed in two phases in 2013 by Byron Berry, Maintenance and Operations Manager, and building construction students at Cochise College under the direction of Instructor Alma Hunt. The system consists of two 660--gallon linked tanks that supply water for landscape plants. Assistance was provided by the Upper San Pedro Partnership and the University of Arizona Cochise County Cooperative Extension Water Wise program.

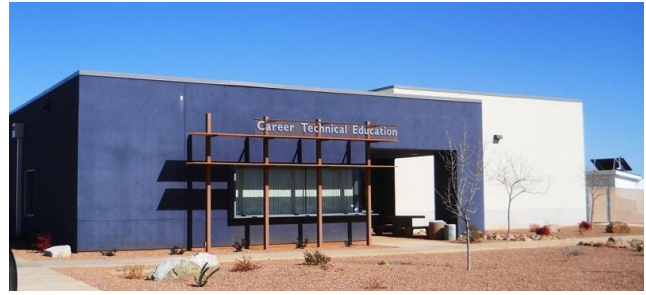
- Harvested water use:* Landscape plants
- Irrigation Delivery System:* Gravity feed to bubblers
- Annual rainfall:* 14"
- Roof collection area:* 2021 ft²
- Roof material:* EPDM – Rubber Roofing
- Annual potential collection:* 16,100 gallons
- Present collection capacity:* About 1200 gallons
- First wash:* No
- Roof Conveyance System:* Wet
- Containers:* 2- 4 x 8 Corrugated Metal Pipes (CMPs)
- Auto fill:* No
- Overflow:* To landscape
